Massachusetts Turnpike

5 Year Reconstruction and Improvement Program

Summary Report 1992

HOWARD NEEDLES TAMMEN & BERGENDOFF
ARCHITECTS ENGINEERS PLANNERS

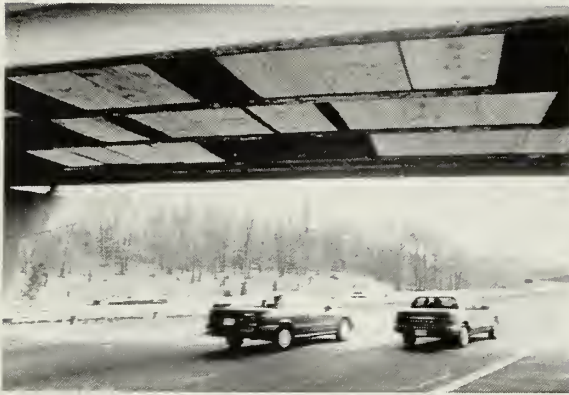
On New Years Day in 1990 a woman travelling along the Turnpike from Boston to the Berkshires narrowly escaped serious injury when a piece of the Oak Street bridge in Weston fell and crashed through the passenger side of her windshield. The impact caused her to lose control of her vehicle and consequently go off the road. Luckily she avoided serious injury, although her car ended up a total loss. Falling concrete has become a significant public safety risk as the Authority's bridge decks advance in age. These incidents pose a risk not only to millions of Turnpike motorists but also to local residents who must travel on local roads which run underneath Turnpike mainline bridges. Pieces of falling concrete vary in weight from a few pounds to several hundred pounds.

Typical Bridge Shielding Installation

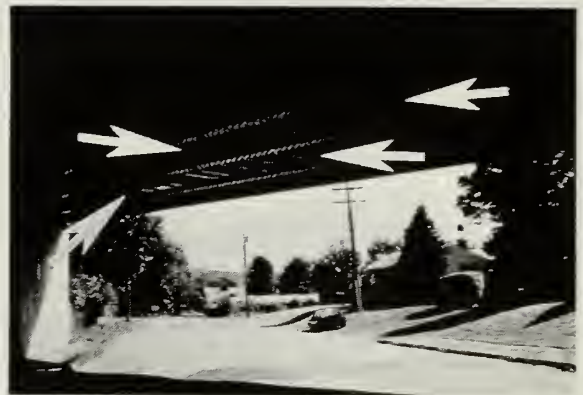
Bridge Shielding Protecting Local Traffic

The chart shown on the following page shows the incidents of falling concrete which have occurred in the months of March, April, May, and June of 1992. MassPike maintenance records from mid-1988 to present indicate that falling concrete has occurred at more than fifty bridge locations. At the present time, a number of these bridges have been shielded with plywood by maintenance crews as a stop-gap measure to help minimize the chance of a serious accident.

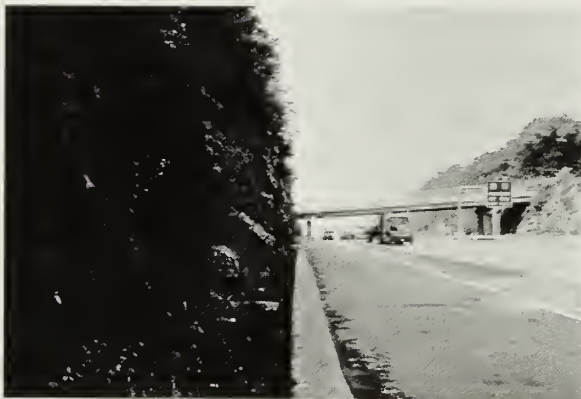
Typical Rock Cut Section with Barrier Wall

The original construction of the Turnpike involved cutting the roadway through sections of rock and ledge leaving large areas of rock and ledge immediately adjacent to breakdown lanes and travel lanes. Due to natural weathering (groundwater flow, freeze/thaw cycles, heavy plant growth, etc.) the rock slopes have, in some cases, become unstable and are in danger of falling onto the travel lanes of the Turnpike. The natural weathering and fracturing has been intensified as a result of the considerable blast damage incurred during construction. The blasting techniques which were utilized resulted in many areas of overbreak, open joints and seams, overhangs and shattered rock. Several significant rock falls have occurred since the original construction, and it has been necessary on numerous occasions to remove rock from the roadway travel surface and subsequently stabilize the slopes to alleviate more serious occurrences in the future.

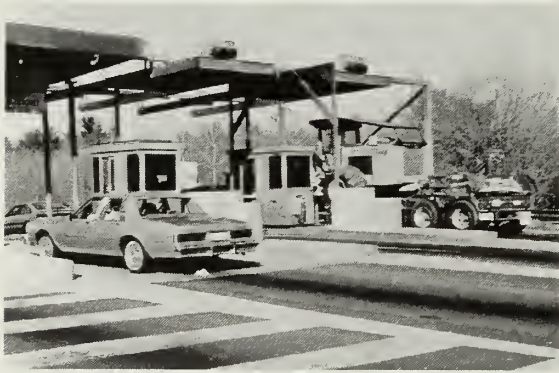
The toll plaza booths and canopies protect and house the Authority's toll collectors and computerized toll collection system. The adequate protection of personnel, computerized collection equipment and electrical systems is important to an effective and accurate toll collection operation. Leaks from aging canopy roofs cause thousands of dollars of damage to costly equipment and electrical wiring. This project provides for repairs to the canopy roofing, canopy drainage, replacement of various temporary elements of booths and canopies with permanent construction, painting of the steel toll booths and canopy framing, and replacement of

Temporary Toll Facilities at Interchange 9

the canopy lighting. Roofing repairs to the canopies will serve to minimize the exposure to leakage, to protect the Authority's substantial financial investment in toll collection equipment, and protect the structures from further corrosion and deterioration. The lighting system will be replaced and upgraded to provide for lighting to increase the level of security and safety of both the Authority's personnel and the motoring public.

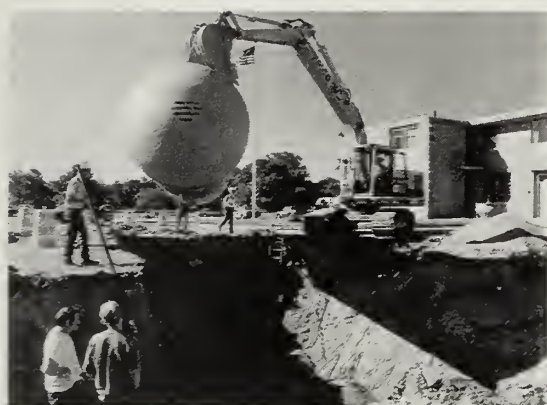
All eleven Service Areas are confirmed disposal sites. Two of the service areas have been identified as priority disposal sites and the Authority has been directed by DEP to undertake remedial measures at these locations. In addition, the Authority has been ordered to immediately undertake Phase II Comprehensive Site investigations at the two priority disposal sites. A proposed scope of work for one site is before the DEP for their review and approval. The second scope of work is in the process of being drafted. To date, the Authority has spent well over \$3 million in costs associated with both the Authority's support facilities and the service areas. It is expected that the costs for assessment and remediation of the service area sites alone could exceed \$14 million.

Underground Storage Tank
